Great East Lake Watershed Survey Report 2021

Acton Wakefield Watersheds Alliance

Great East Lake Improvement Association

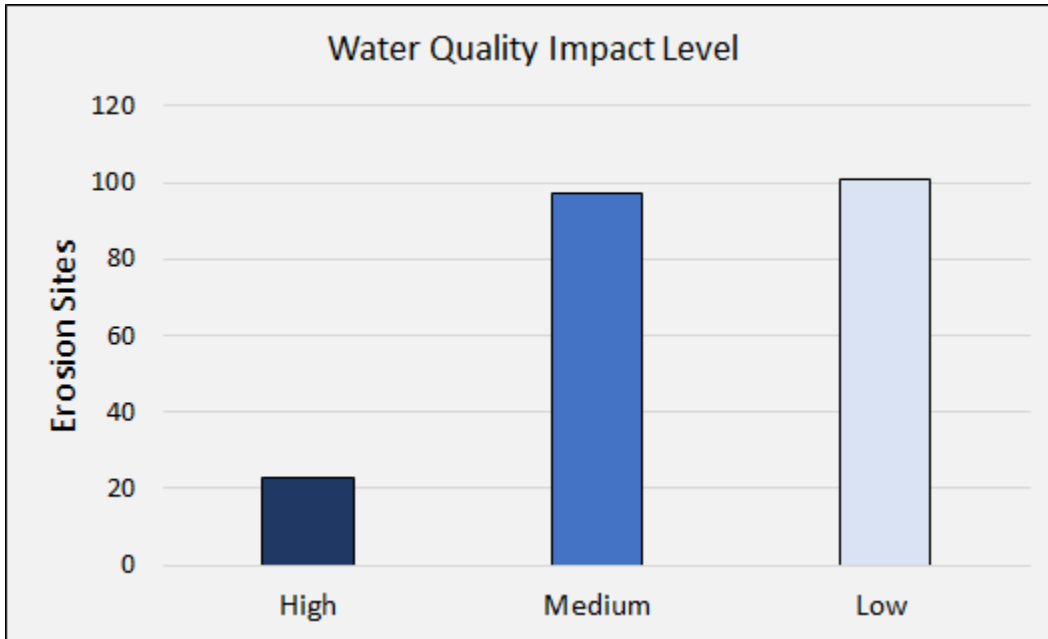
Figure 1. Identified Erosion sites based on estimated water quality impact.

Volunteers identified 220 erosion sites that were directly impacting Great East Lake. Of these 220 sites, 101 were low impact/ low priority erosion issues, 97 were medium impact, and 23 were deemed a high impact/high priority. All three of these categories had a range of costs and technical complexity associated with fixing erosion. Figure 1 demonstrates this breakdown.

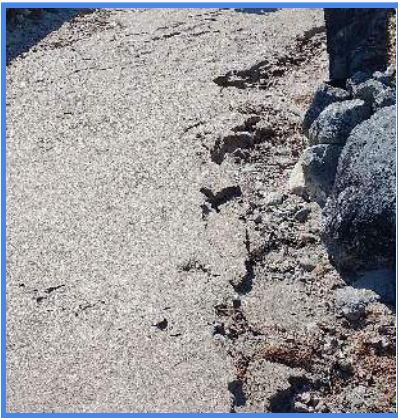
Gully Erosion - forms when fast moving water forms a channel on bare soil and begins to pick up and transport sediment downhill to the lake. Most visually obvious form of erosion. Smaller gullies are referred to as rills.

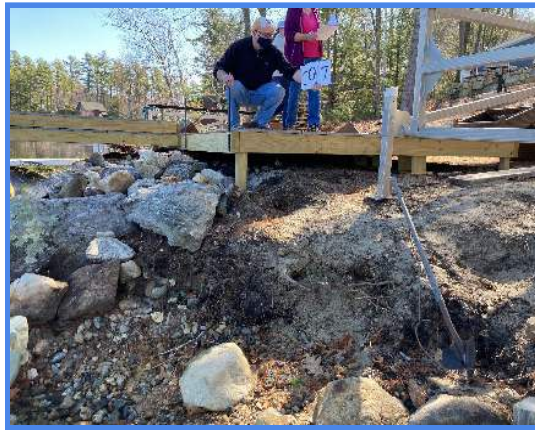
Shoreline Erosion - Shoreline can erode both from stormwater runoff and intense wind and wave action. The root systems of plants on the shoreline work to stabilize soil on the slope and protect it from eroding. In the absence of permanent, woody vegetation, the bank soils have no structure and can easily erode into the lake.

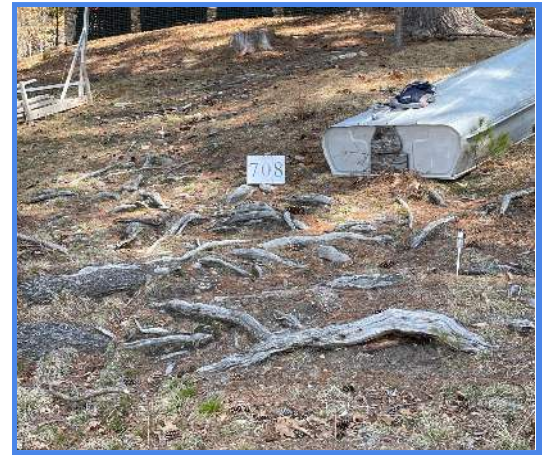
Sheet Erosion - Less apparent than a gully. Occurs when soil erodes in equal amounts across the landscape and the soil level lowers. Exposed roots are evidence of this. Roots naturally grow underground, so the amount of soil loss equals at least the height of the exposed roots. Sheet erosion often goes unnoticed and can lead to significant soil loss.

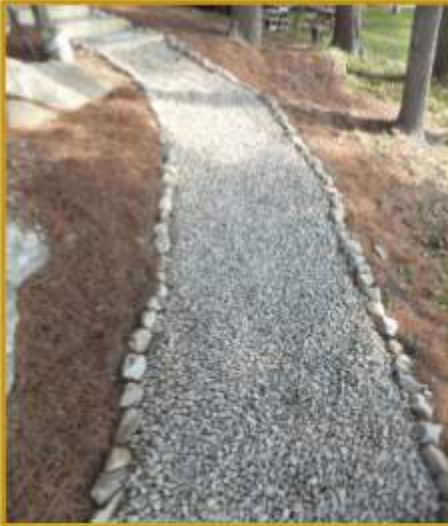
Infiltration Path - a trench filled with crushed stone that traps stormwater. Can replace dirt paths susceptible to runoff.

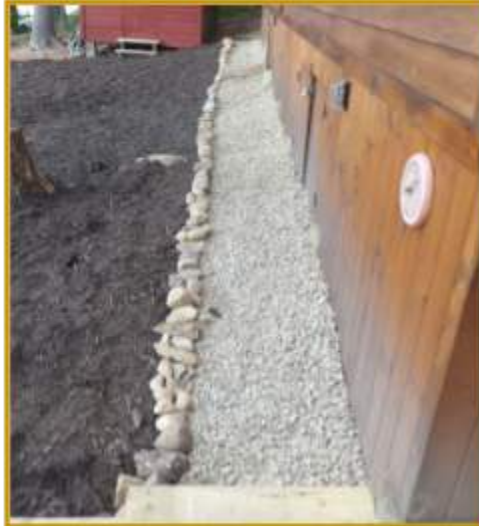
Dripline Trench - Traps roof runoff and directs it into the ground. An alternative to gutters.

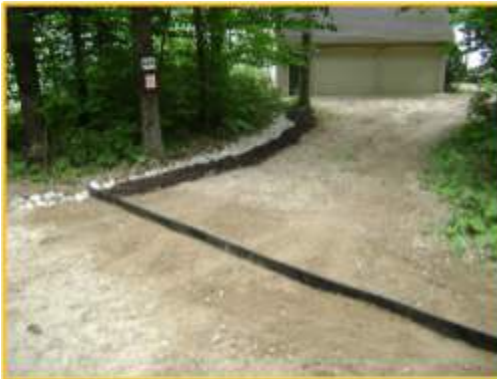
Rubber Razor - strips of hard rubber are partially buried in the driveway, placed on an angle to divert stormwater into an adjacent trench or natural area.

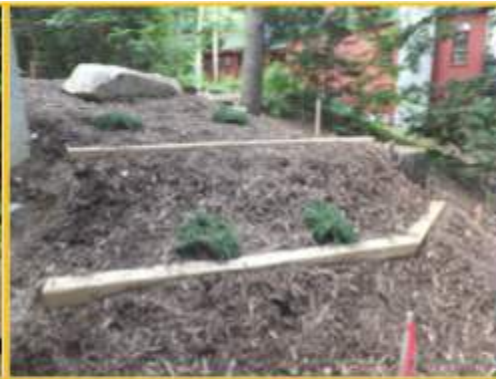
Water Bars - 6"x 6" lumber is installed on a slope with crushed stone on the uphill side to trap and divert stormwater. Water bars are left slightly raised to slow water down and can be used as seen above, or placed in a pathway in shorter lengths to function as steps.

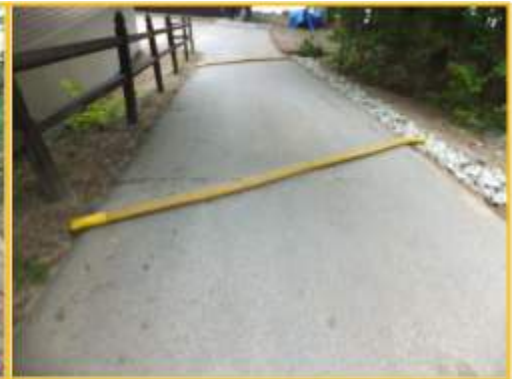
Firehose Diverter - In paved driveways, burying rubber and wood are not an option. Old firehose, or other durable material, can be filled with sand or stone and placed on an angle to divert stormwater. These have the added benefit of being movable.

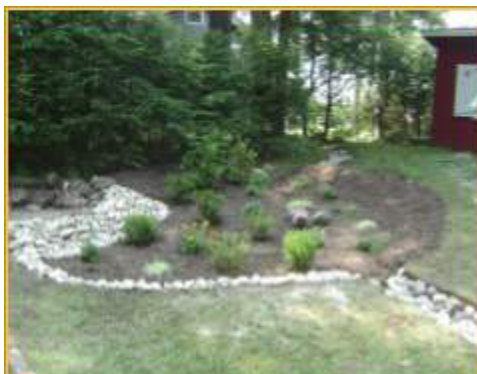
Rain Garden - pervious detention basin designed to store stormwater during a rain event and allow it to infiltrate. Typically a trench directs water into the rain garden. Water tolerant plants are put in to uptake additional water and absorb excess nutrients.

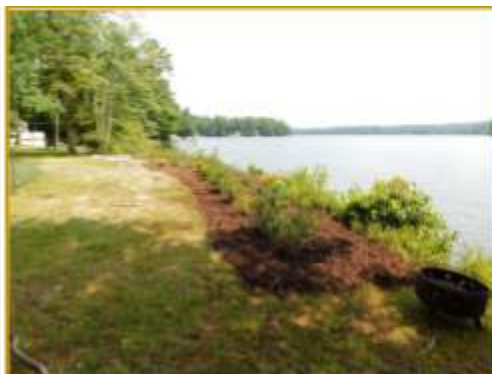
Vegetated Buffer - The shoreline is the last line of defense from stormwater. Dense, woody vegetation slows down stormwater and the root system binds sediment together and keeps it from eroding.

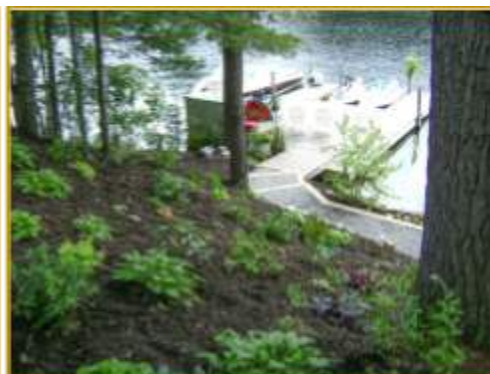
Erosion Control Mulch - This chunky mulch is made of tree and stump grindings of various sizes, this allows it to bind together and trap stormwater without washing away. This is the simplest way to protect bare soil and will last for many years before breaking down.

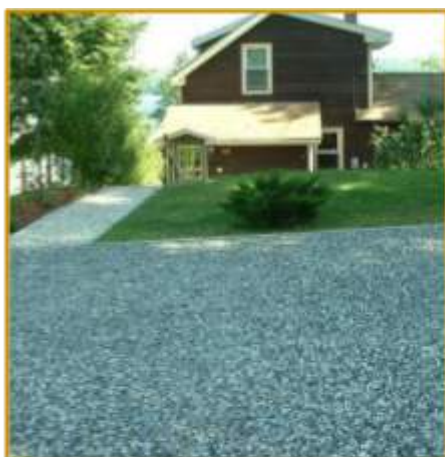
Hard Pack - This is an aggregate stone material that does not wash away as easily as sand and gravel. The lack of fine materials means less sediment erosion.

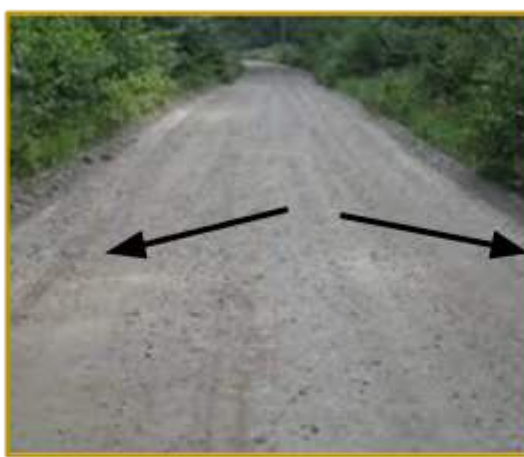
Crowning - A dirt road must be slightly pitched so water will run off of it instead of forming potholes and gullies. The high point can be in the middle to direct water in both directions, or on a far side to direct all water in one direction.

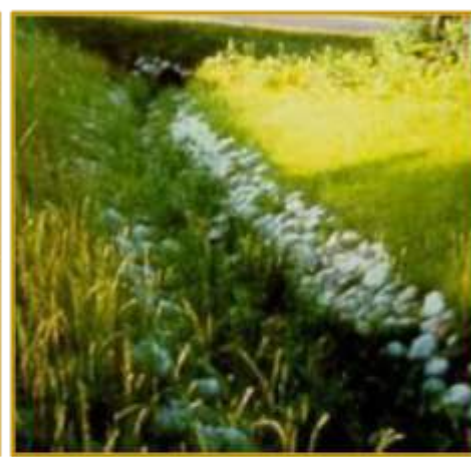
Ditching - Once water is directed off the road, it should flow into a pervious ditch to allow it to infiltrate. There are various methods such as vegetation and check dams which can be used to slow stormwater down in a ditch.
